A FLECK PERFORMANCE BULLETIN

November 10, 1993

5600 Control Valve Vibration Noise

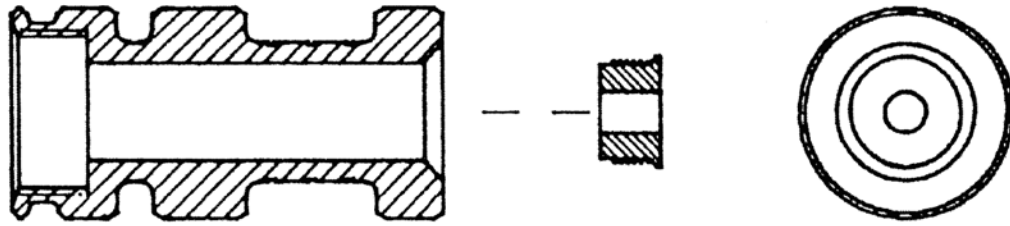
FIGURE 1

We have heard reports of a loud vibrating noise on the 5600 filter control as the piston is going into backwash. This noise is caused by the change in water flow direction from preliminary rinse to backwash, which sometimes results in vibrations until the drain port has fully opened.

To eliminate this flow induced vibration, all 5600 standard and filter pistons built after October 4, 1993 are being fitted with a noise suppressor plug pressed into the end of the piston (Figure 1). The noise suppressor part #18647 (black) is for the 5600 filter piston, and part #18649 (white) is used for the 5600 softener piston (Figure 2).
