# PERFORMANCE BULLETIN

August 20, 2001

## New Auxiliary Brine Cam Switch & Motor Bracket

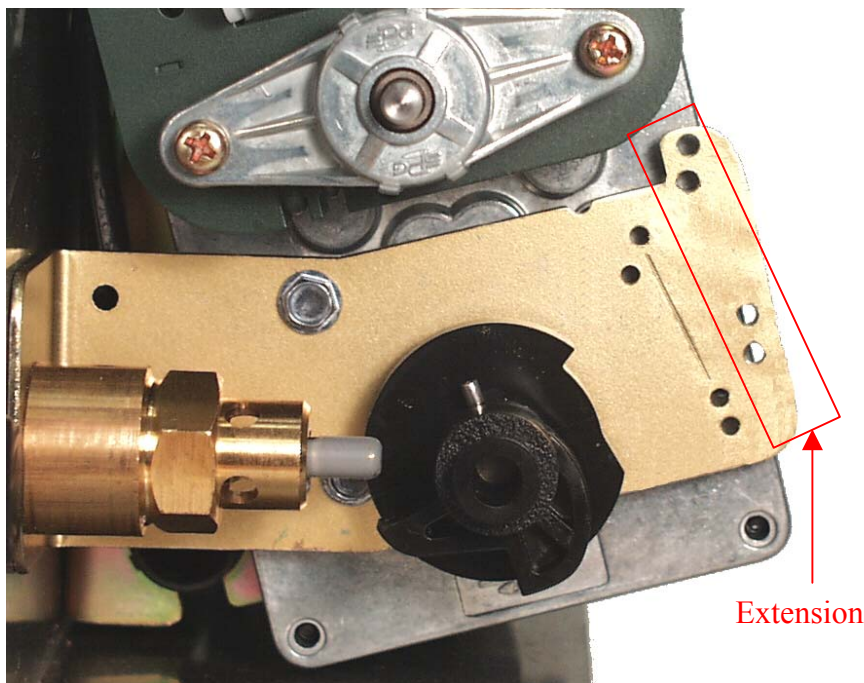
Figure 1

Due to the change of our drive motors, the auxiliary brine cam switch and motor bracket will be changed to improve the wiring of the auxiliary switch. Effective mid September 2001, an **extension** (Fig. 1) will be added to the motor bracket to accommodate the new **auxiliary switch** (Fig.2) on all 1500, 2510, 2750, 2850, and 2900 control valves.

The new bracket will retrofit existing control valves. The new bracket part number will be **11826-02** and the auxiliary switch is **10896**. On the backside is a picture showing the auxiliary switch positions and locations for both the old and new style switches.

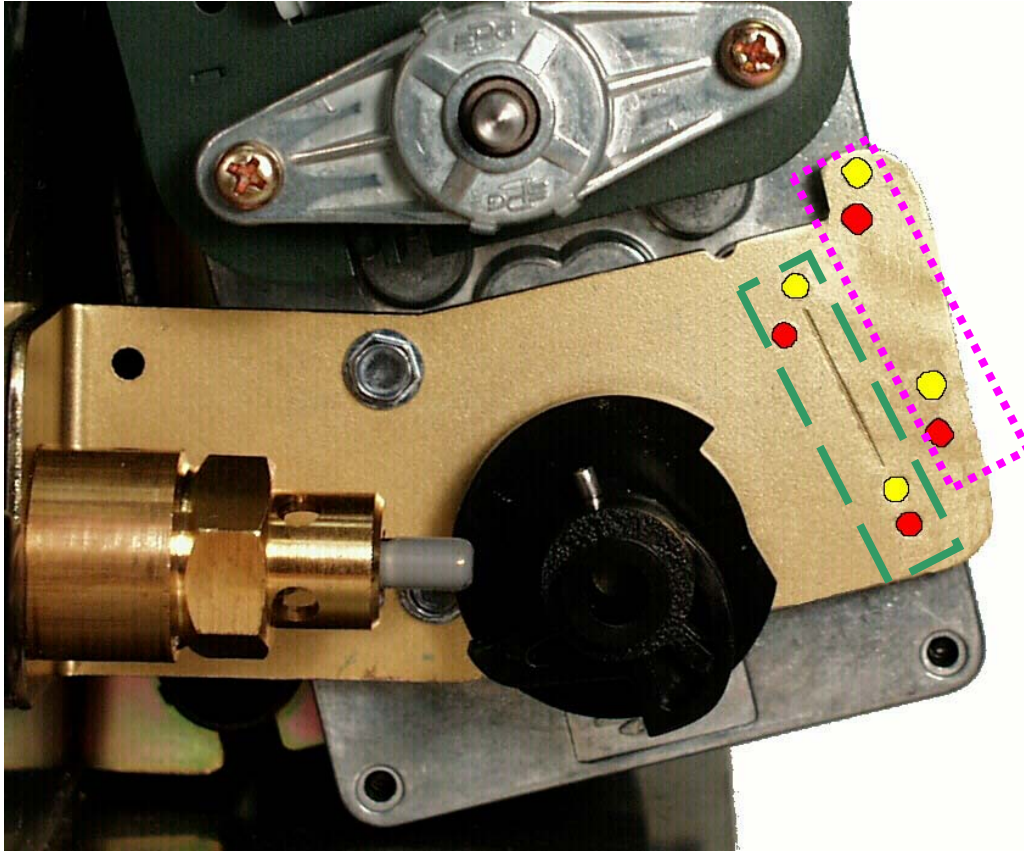
## Auxiliary Switch Positions and Locations

Auxiliary Switch:	10218
Auxiliary Switch Kit:	60320-07
Switch Location:

Turn on the start of regeneration Shut off after Brine Tank Refill

Turn on the start of regeneration Shut off after Rapid Rinse

Auxiliary Switch:	10896
Auxiliary Switch Kit:	60320-12
Switch Location:
