PERFORMANCE BULLETIN

September 10, 2001

5600 Replacement Timer Motor Caution

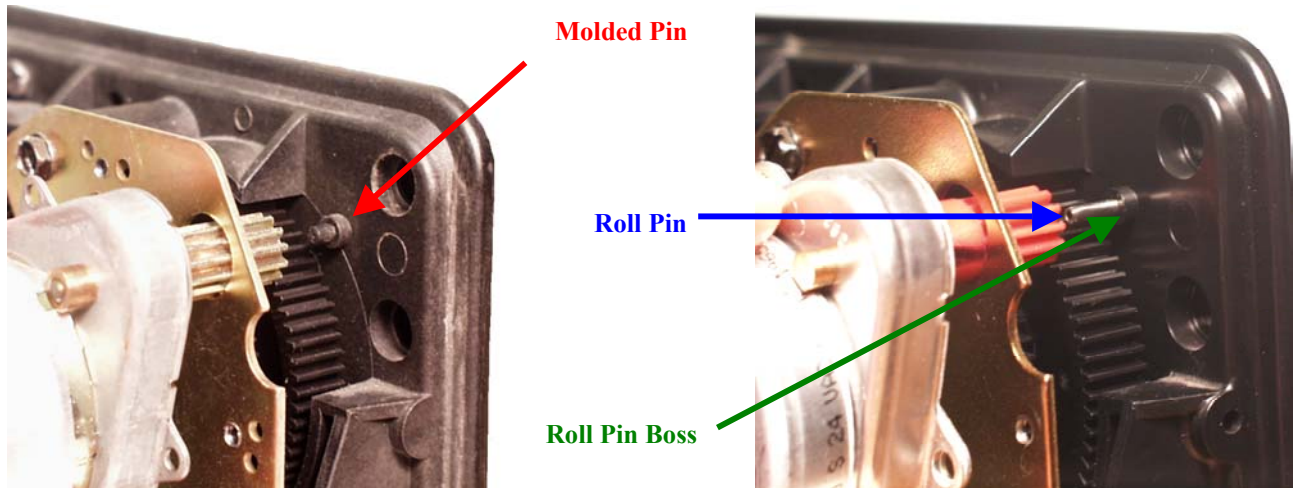
Figure 1 The **molded pin** is broken off.

Figure 2 The **roll pin boss** is cracked. In addition, if the **roll pin** has fallen out, there is a strong possibility that the boss is cracked.

Dated from:
Standard September '77 – July '93
"L" January '82 – July '93

Dated from:
Standard July '93 – May '97
"L" July '93 – February '00

Failure to replace the housing under these circumstances may cause the drive motor to fail prematurely.

NOTE: We have added more material to the **roll pin boss** after the dates listed above in figure 2 to help prevent cracking.
