# PERFORMANCE BULLETIN

March 12, 2002

## 6600 & 6700 Electronics Update

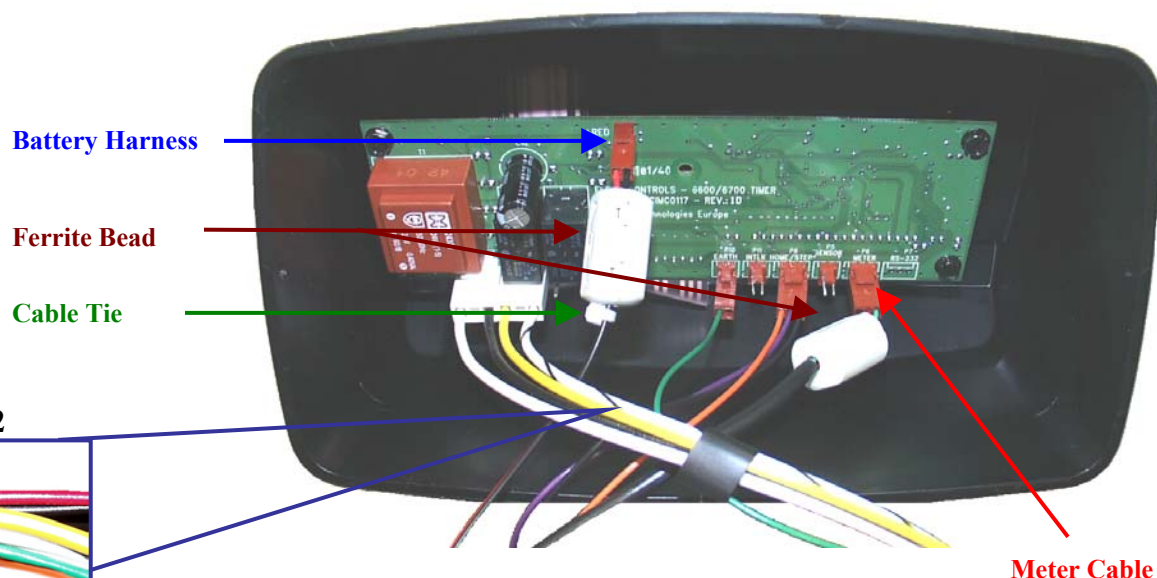
Fig. 1

Since January 2002, we have been investigating recent complaints from the field regarding some 6600 and 6700 metered control valves. These valves have exhibited the same erratic behavior found last year in time clock regeneration control valves.

The symptoms above may occur due to the electrical environment in which the control valve is installed. Only a limited number of valves are experiencing these symptoms, however we are addressing this issue in the following way:

As of February 19, 2002 we are also installing ferrite beads onto the battery harness and the meter cable. These ferrite beads will eliminate electrical interference entering the control through the meter cable and battery harness, causing timer failure.

For field installations (see fig. 1) snap a **ferrite bead** (P/N 40508) around the **battery harness** close to the connector that plugs into the circuit board. Install a **cable tie** (P/N 14044) just below the **ferrite bead** to lock it into place. Snap another **ferrite bead** around the three individual **meter cable** wires close to the connector that plugs into the circuit board. A cable tie is not required for the ferrite bead on the meter cable. Finally, (see fig. 2) remove the cable tie that has all wires tied together and separate.

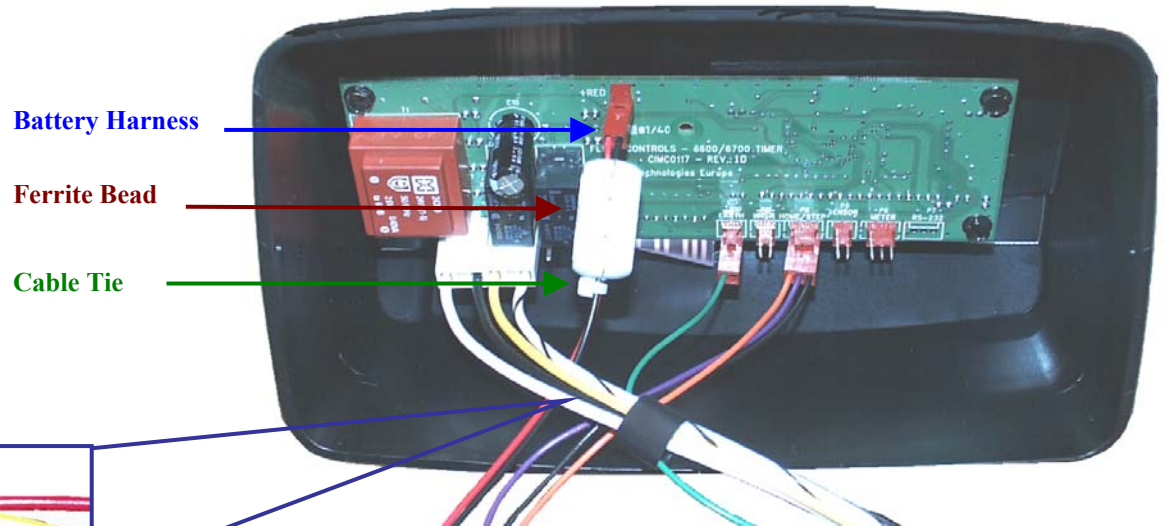
**Fig. 1**

From May 2001 to current we have been installing ferrite beads on the battery harness. This ferrite bead eliminates the electrical interference entering the malfunctioning control through the battery harness. Prior to implementing the ferrite bead solution meter cables were installed on time clock control valves between February 2001 to May 2001 as a measure to eliminate electrical interference.

For field installation (see fig. 1) snap a **ferrite bead** (P/N 40508) around the **battery harness** close to the connector that plugs into the circuit board. Install a **cable tie** (P/N 14044) just below the **ferrite bead** to lock it into place. Finally (see fig. 2) remove the cable tie that has all wires tied together and separate.
