**2 TANK SEQUENTIAL FILTER
SEPERATE BACKWASH SOURCE**

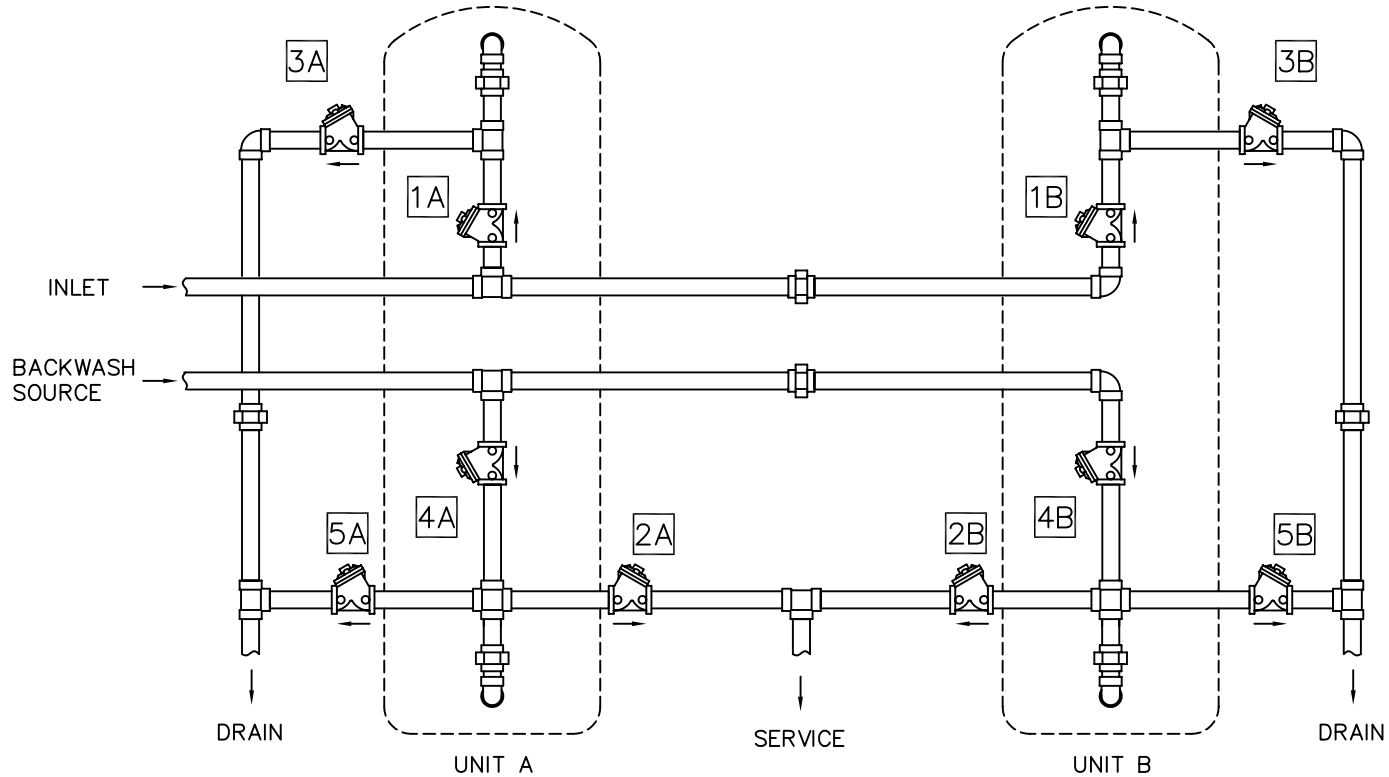
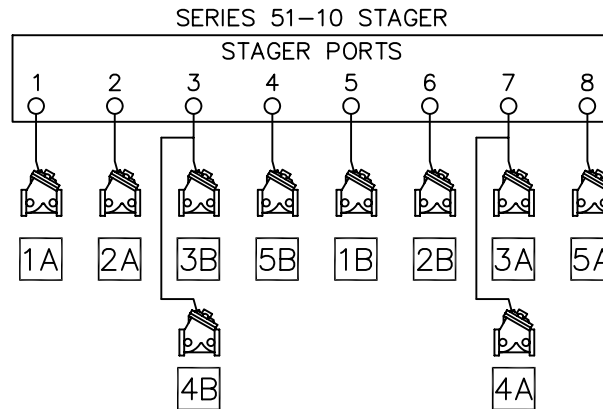
1. ALL OTHER PORTS PRESSURIZED.
2. ALL VALVES NORMALLY OPEN, PRESSURE TO CLOSE.
3. DRAIN LINE FLOW CONTROLLER NOT SHOWN.

NOTCH	POS.	FUNCTION	PORTS VENTED (NOTE 1)	VALVES OPEN
A	0	SERVICE	1,2,5,6	1A,2A,1B,2B
B				
C	1	BACKWASH UNIT A	5,6,7	1B,2B,3A,4A
D	2	RINSE UNIT A	1,5,6,8	1A,1B,2B,5A
E				
F				
G	3	BACKWASH UNIT B	1,2,3	1A,2A,3B,4B
H	4	RINSE UNIT B	1,2,4,5	1A,2A,5B,1B

B	ON PIPING DRAWING, VALVE 1A WAS SHOWN AS VALVE 5A	NONE	MSM	04JUN03	
A	INITIAL RELEASE	NONE	JWB	31JUL01	
REV	DESCRIPTION	ECO	DWN	DATE	APVD
 20580 Enterprise Avenue Brookfield, WI 53045 888.784.9065 www.Pentairwatertreatment.com					
2 TANK SEQUENTIAL FILTER W/ SEPERATE BACKWASH SOURCE					
SCALE	DRAWN	DATE	DWG. NO.		
N/A	JWB	31JUL01	1078284
